SUBJECT: **ITEM 02 – Vulcan Steam Room and Sauna**

Report to the Historical Resources Board

SUBJECT: **ITEM #1 – Vulcan Steam Room and Sauna**

**For 805 W. Cedar Street
San Diego, CA. 92101**

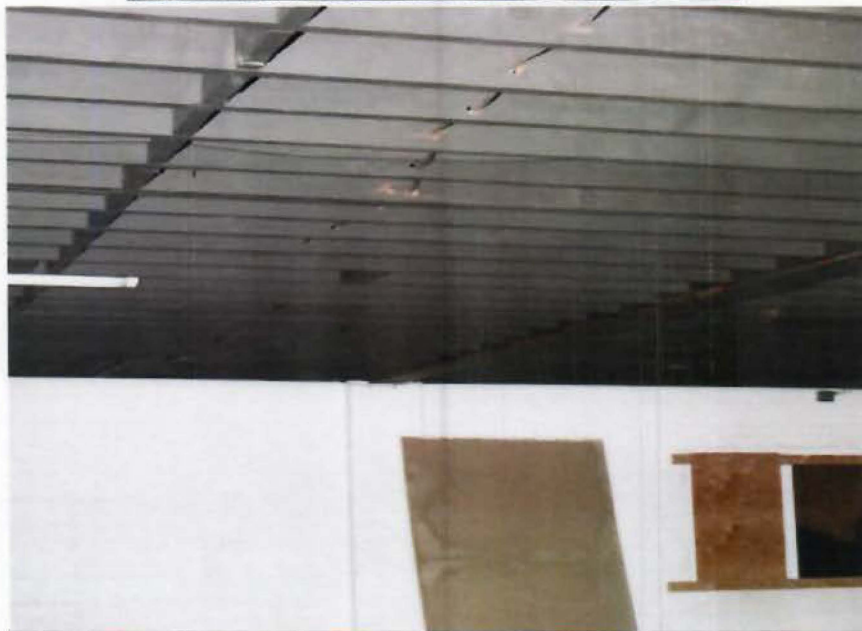
For the lateral resisting system of the building all the exterior walls are concrete with a flexible diaphragm for the roof system. The roof diaphragm should tie back to the top of the concrete walls to create out of plane stability to the walls. Due to heavy weight of the concrete walls, the roof diaphragm should be designed as a high-strength diaphragm to support top of all concrete walls and prevent any out of plane instability in seismic events. Currently there is no tie back connection between the existing roof trusses and the walls in both parallel or perpendicular conditions to concrete walls. See *Appendix A, Images #1, #2*.

Image #2 shows the joist parallel to CMU wall
Without any tie connection to two story CMU wall

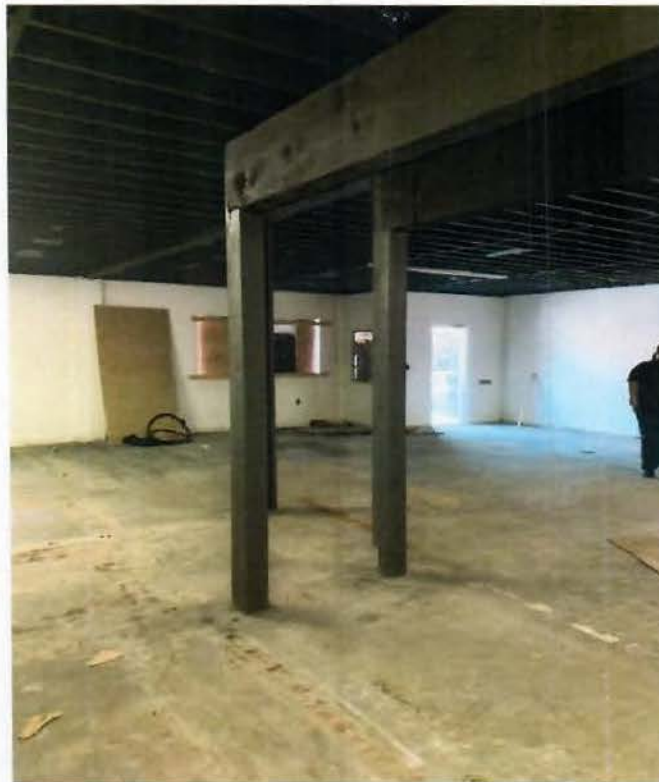
The existing roof framing system is a flexible diaphragm which is supported at the middle with a concrete beam, which usually is required to be braced with the diaphragm at the compression side. The existing flexible diaphragm will not provide the fully braced concrete beam. Part of the roof framing is deteriorated due to water damage. The floor framing is composed of 2x members which are supported at the center of the building with either a steel beam or wood beam. The wood beam is under supported with a double 2x4 posts for the 16 ft span beam. This is under designed, please see the attached calculation under *Appendix B*. Also, there is a portion of the floor framing in the center of the building which does not have any support and the joists are spliced creating an unsafe condition that will result in the floor system failure when live loads are applied to it. See *Appendix A Images #3, #4, #5 and #6*.

Image #3 shows the floor joist supported with wood beam which support with 2-2x6 stud

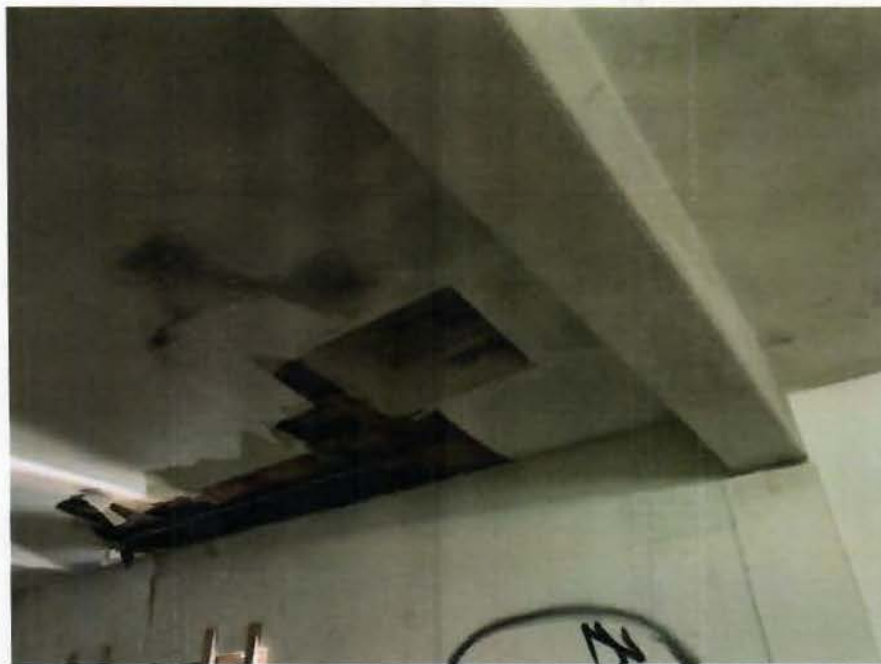
The flooring at some areas is defected due to water damage and faulty construction. See Appendix A, Images #4, #7.

Images #4 shows the concrete beam support the flexible diaphragm and deterioration of the roof framing

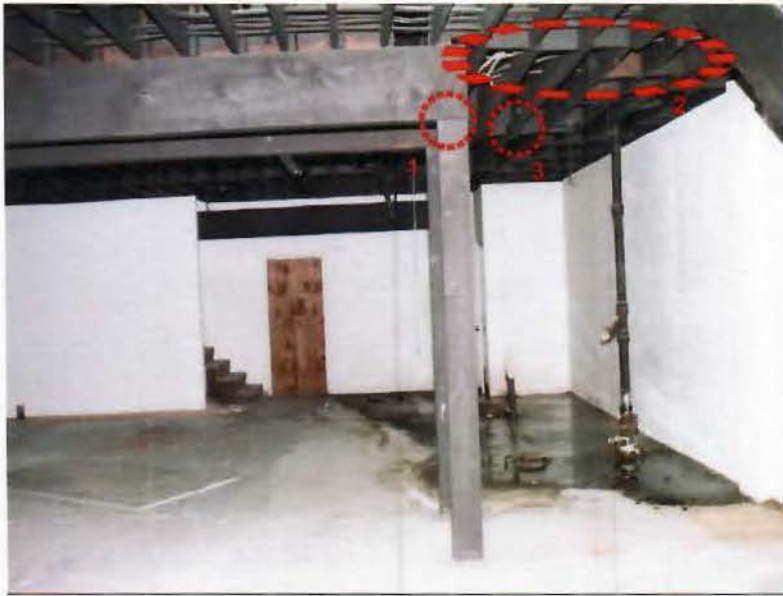
Image #5 show the portion of the floor with out any support at the middle with spliced joist

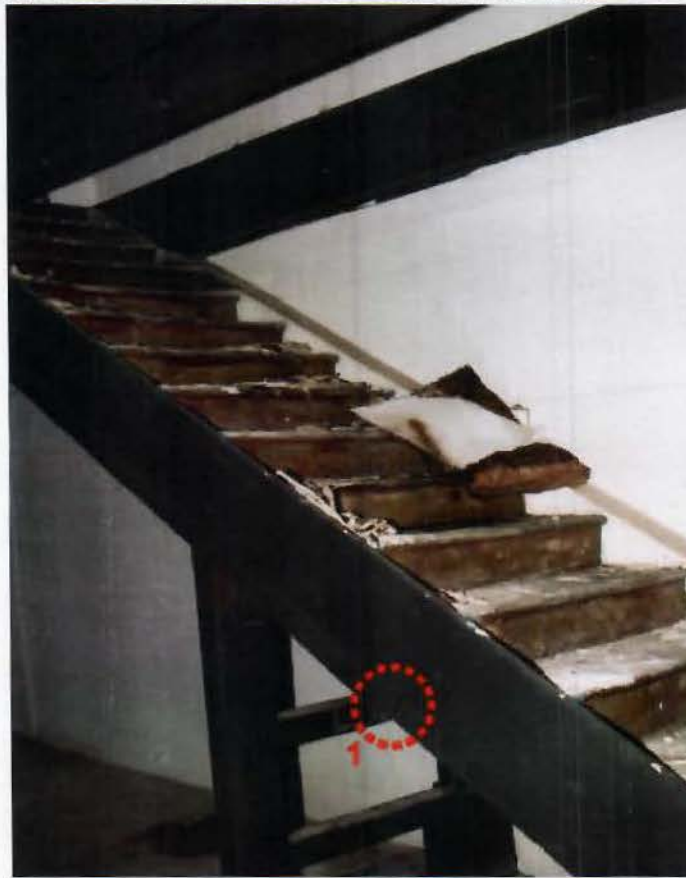
There is one stair case inside the building which is poorly constructed and damaged and unsafe to serve as a portion of the means of egress. The construction of the staircase is inadequate to support the live loads applied to the structure.

Image #6 shows the stairs case with splice at the stringer and deteriorated wood

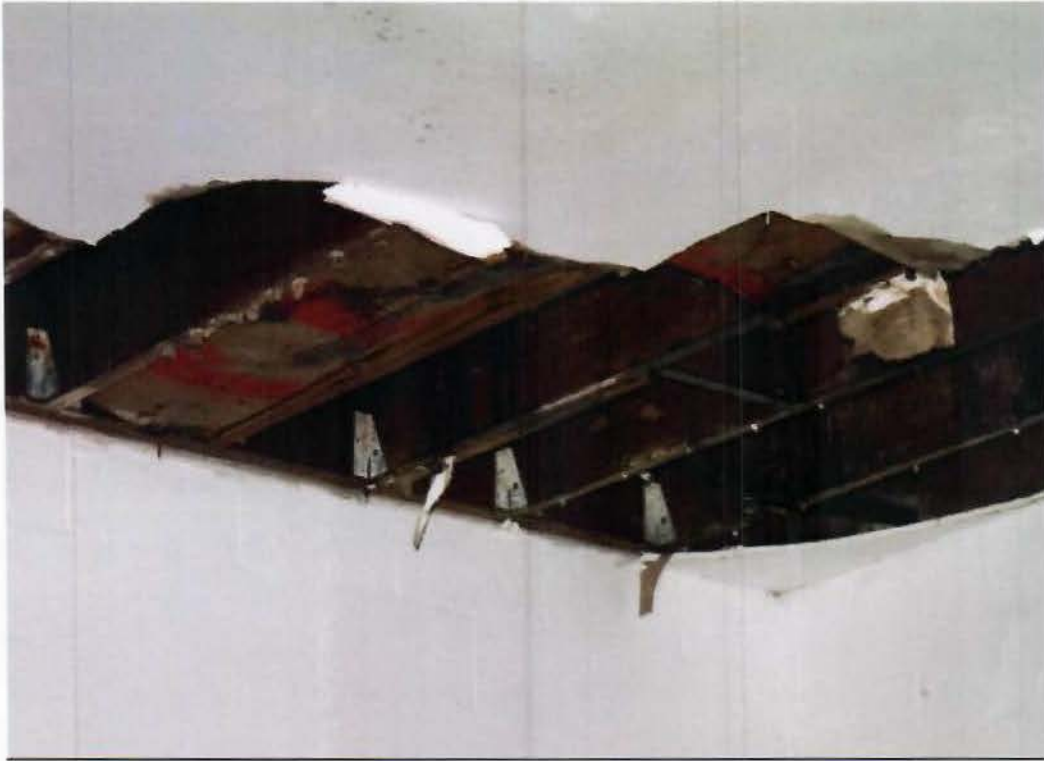
Image #7 shows the roof framing deteriorated wood as well as notched joist

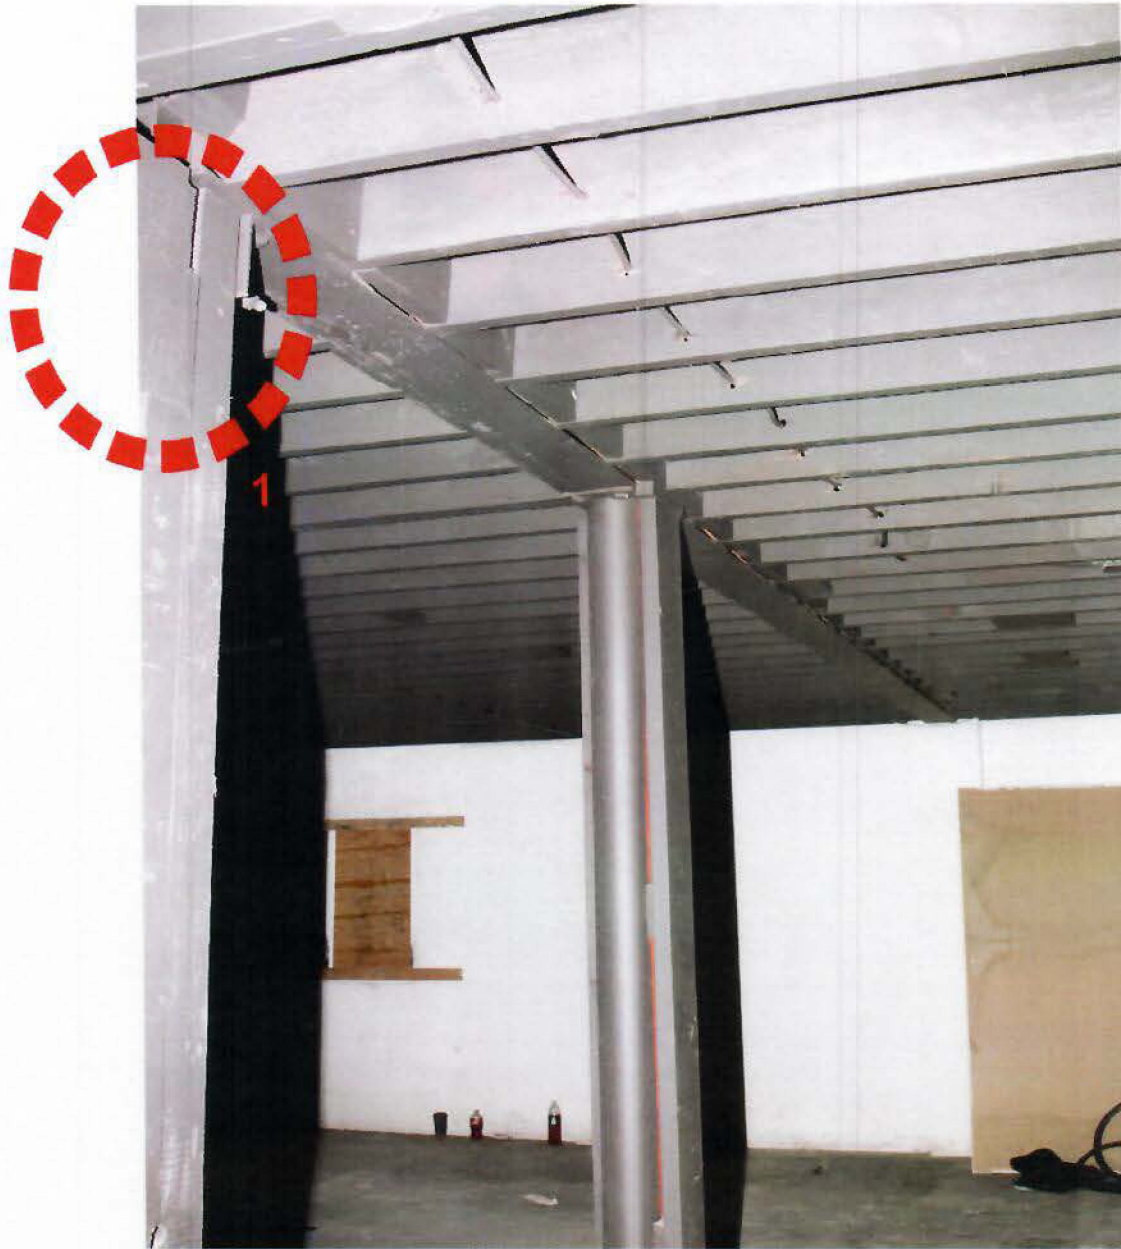
COLUMN & WOOD BEAMS

1. INSUFFICIENT BEAM POST CONNECTION WITH NO HARDWARE. BEAM TOE-NAILED TO POST.

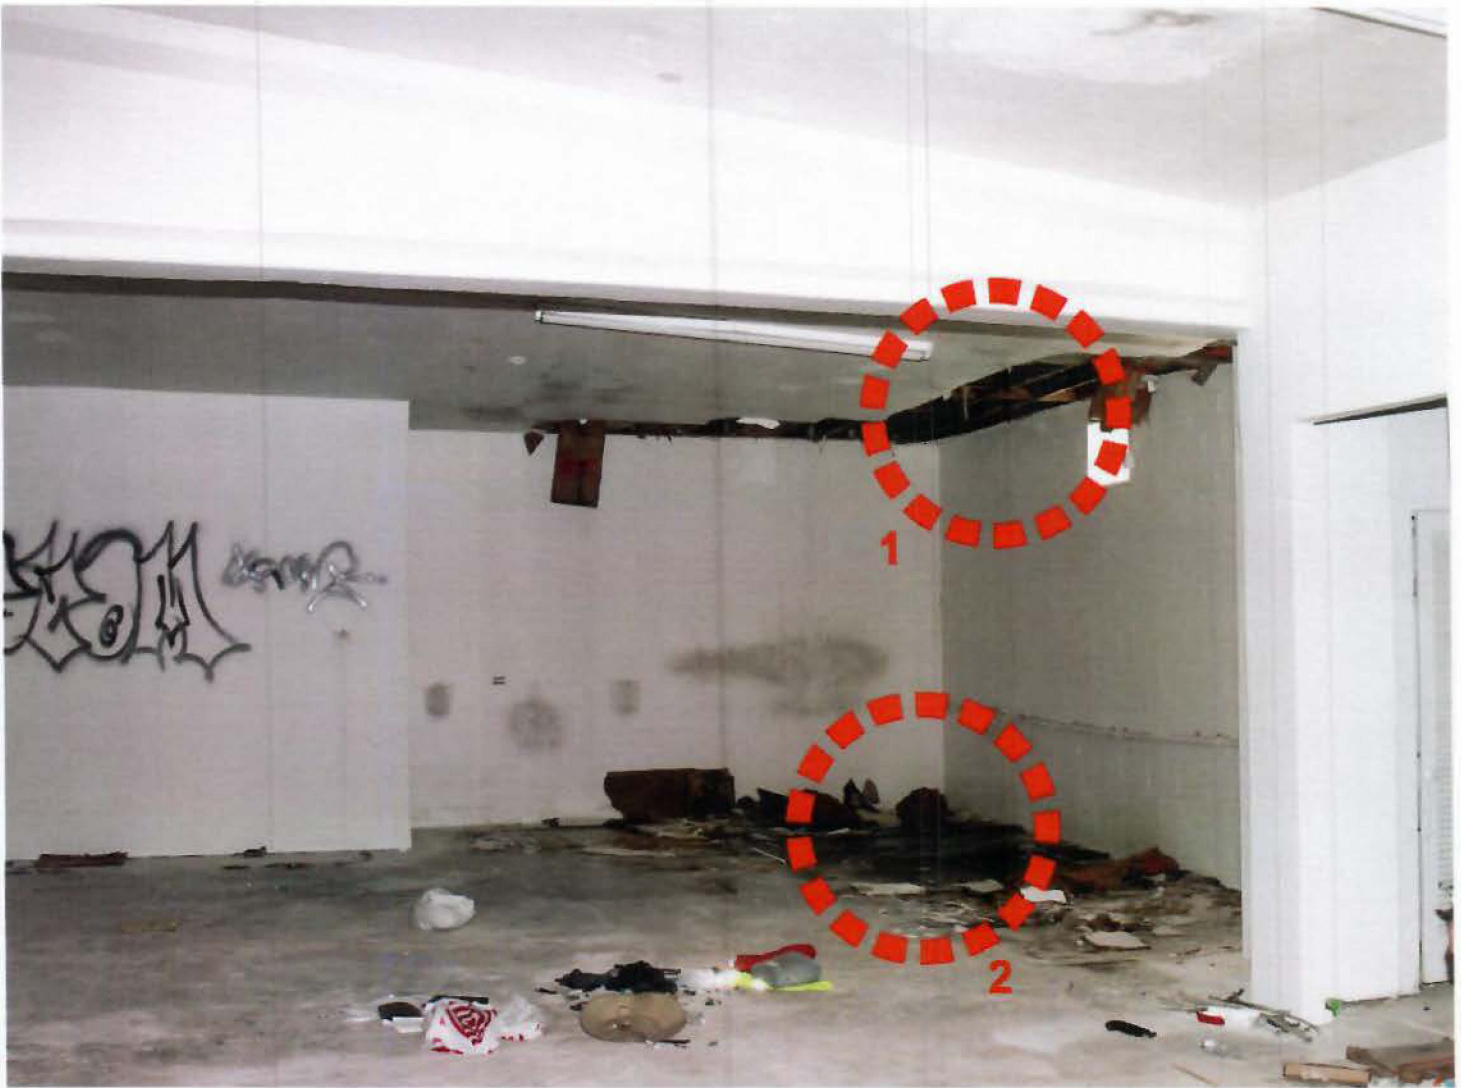
CONCRETE BEAM

- 1. WATER DAMAGED ROOF FRAMING MEMBERS**
- 2. WATER DAMAGE AT FLOOR. FLOOR JOISTS AND PLYWOOD DIAPHRAGM HAVE INCURRED SUBSTANTIAL DAMAGE.**

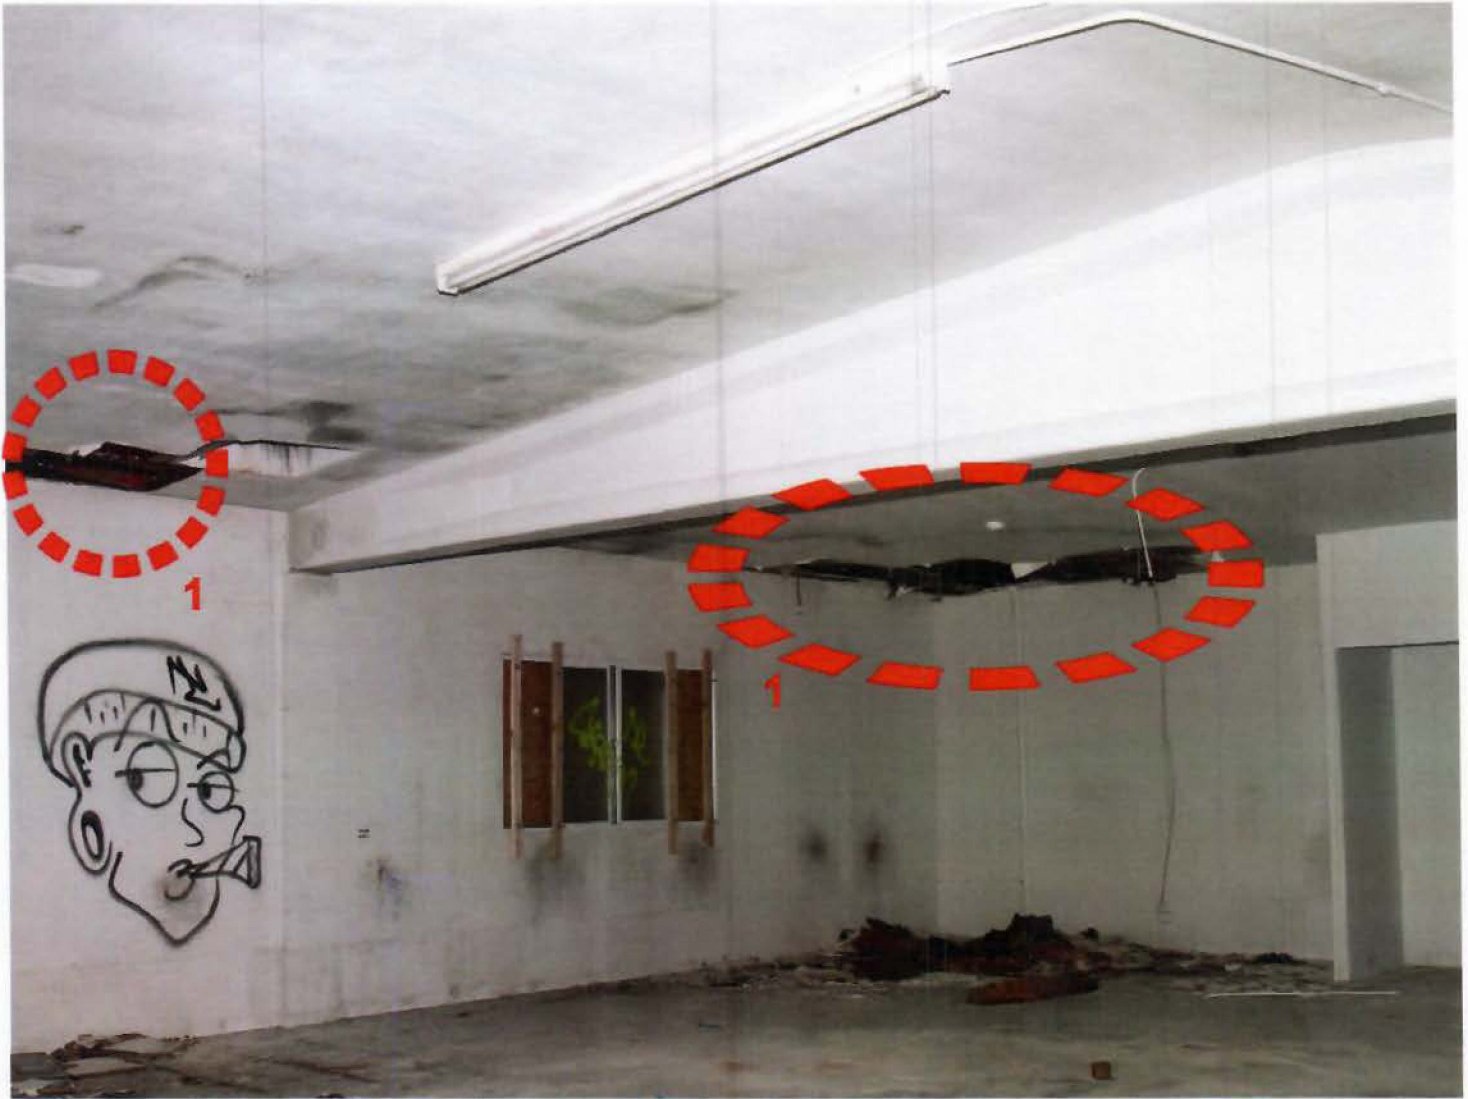
2ND FLOOR
INTERIOR CEILING

- 1. WATER DAMAGED ROOF FRAMING MEMBERS**
